NONDESTRUCTIVE EVALUATION OF STRUCTURAL CERAMICS BY PHOTOACOUSTIC MICROSCOPY FINAL REPORT

ALLISON GAS TURBINE DIVISION
General Motors Corporation

**PREPARED
for
NATIONAL AERONAUTICS
AND
SPACE ADMINISTRATION**

**NASA LEWIS RESEARCH CENTER
CONTRACT NAS3-24390**

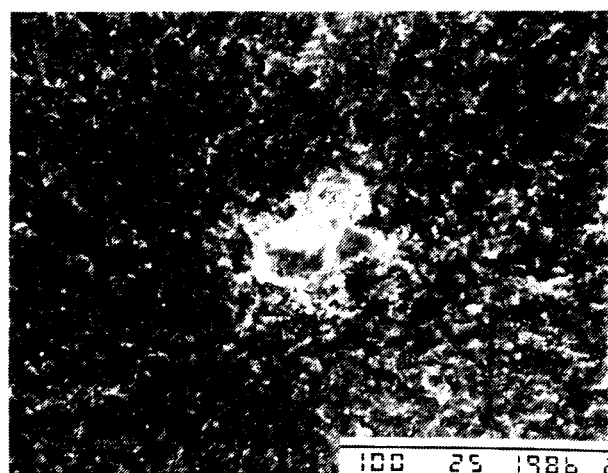
No. A39

SEM

Internal
inclusion

$a = 38 \mu\text{m}$
 $2c = 47 \mu\text{m}$

PAM image

20x
